T.I.P. Troubleshooting Information on Power Gear

Inner Rail Realignment

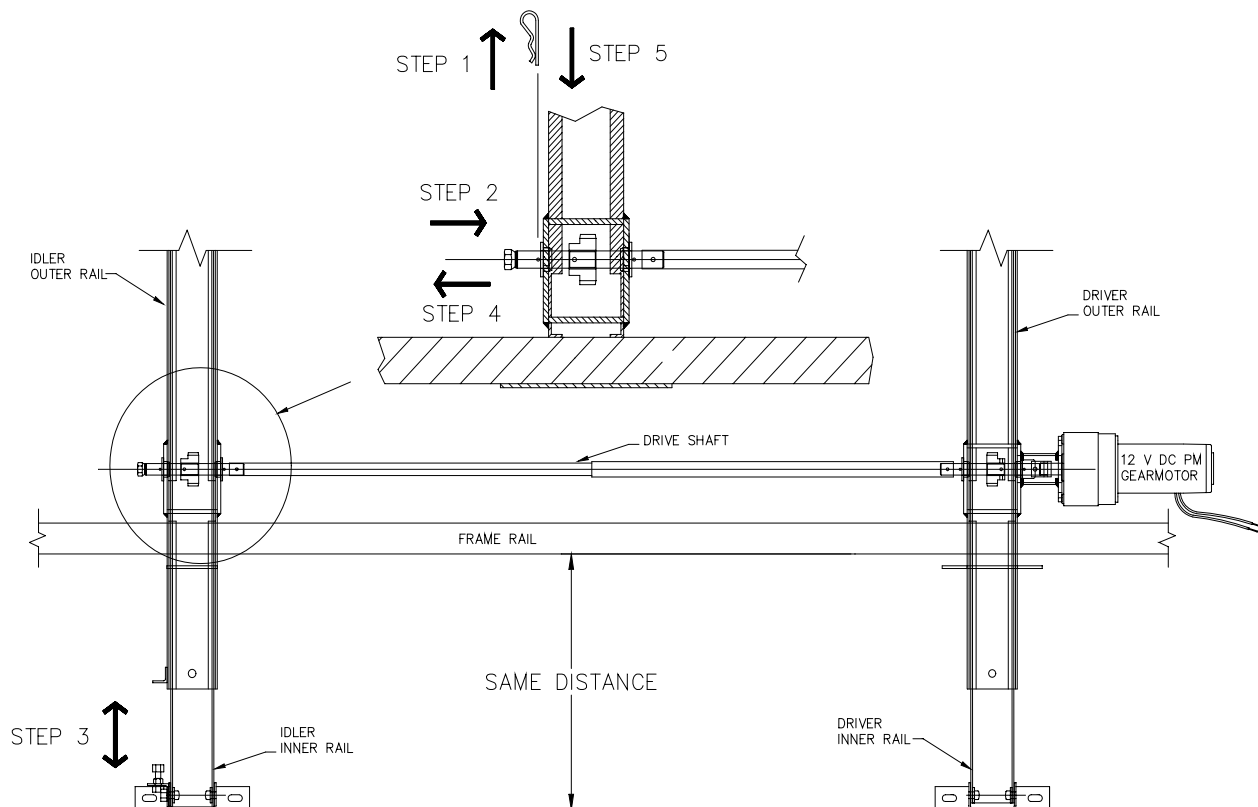
1. Remove cotter hairpin from idler drive shaft.
2. Push the idler drive shaft toward inner rail to disengage the gear from the gear rack.
3. Adjust the room by sliding the idler rail side of the room to the proper position (same distance from the frame as the drive rail side).
4. Push the idler drive shaft back into position engaging the gear and the gear rack.
5. Reinstall cotter hairpin in idler drive shaft.
6. Extend and retract room a couple of times and check for proper room flange sealing.
7. If room is not aligned properly, repeat steps 1 thru 6.
